Tamworth Town Office

Level II Energy Audit

September 20, 2023

Prepared by: *Resilient Buildings Group, Inc.*

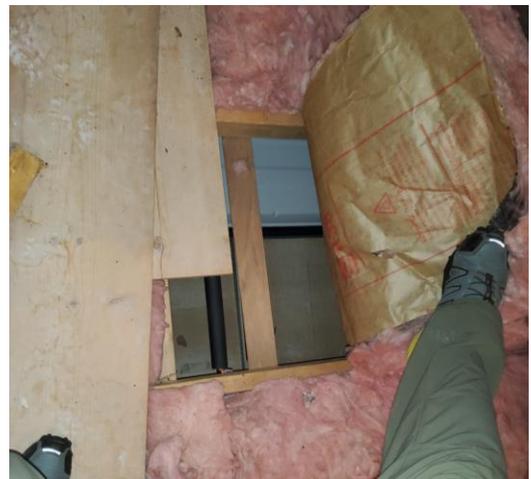
- **B1. EEM: Air-seal and Insulate Attic Floor.** During our inspection of the attic space and review of the drawings, we discovered the building does not exhibit any sort of air barrier across the attic floor. This allows for a large amount of air communication between the interior building space and the attic, which is connected directly to the outdoors via attic venting. Our blower door test results were also quite high, further confirming that this lack of air barrier is a major source of air leakage in the building. Without an air barrier at the attic floor, the building will lose much of its heat in the winter and gain heat during the summer. We recommend installing a smart vapor retarder membrane on the underside of the attic floor (see images to the right). In addition, the attic is currently only insulated with R-38 fiberglass batts. We typically recommend R-60 in the attic for high-performing buildings. To achieve this, we recommend adding 6" of loose-blown cellulose to the attic floor.

Attic floor with no air barrier between acoustic ceiling and attic space

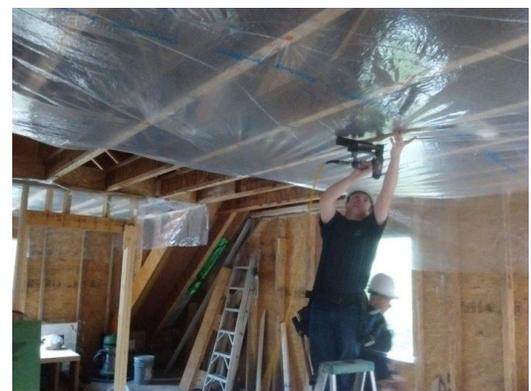
Smart vapor retarder membrane stapled to attic floor joists (photo credit: Fine Homebuilding)

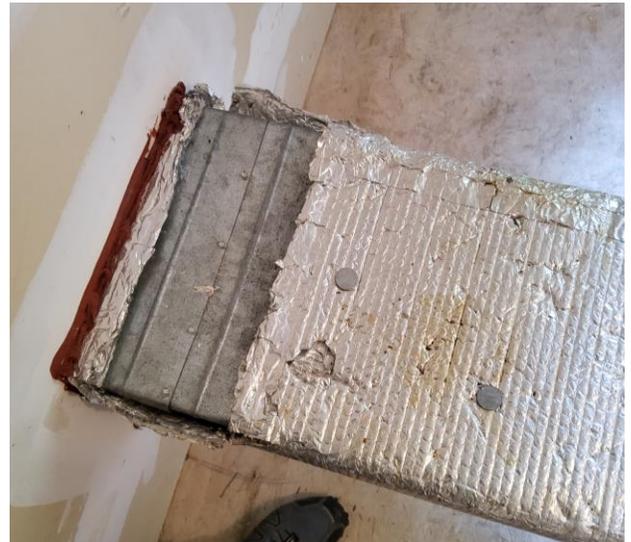
Inadequate insulation on ductwork

- **M3. EEM: Add Ductwork Insulation.** If the ductwork is maintained for any reason, the insulation should be repaired and improved. Currently, the ductwork is insulated with a thin layer of foil-faced insulation that has several missing and damaged segments. This ductwork comes in direct contact with the air in the attic space, which is connected directly to the outdoors via attic venting. To inhibit heat transfer between the ductwork and the attic air, we recommend adding a layer of 2” thick foil and fiberglass duct insulation around all ductwork in the attic.
